SUBJECT: Physical Property Testing on the Shells of Mammary Implants

MAMMARY ENVELOPE PRODUCING PROBLEMS TO DATE - 1976

SUBJECT: PROJECT REPORT - COMPLAINT ANALYSIS, PLASTIC SURGERY

MEDICAL DEVICE REPORT

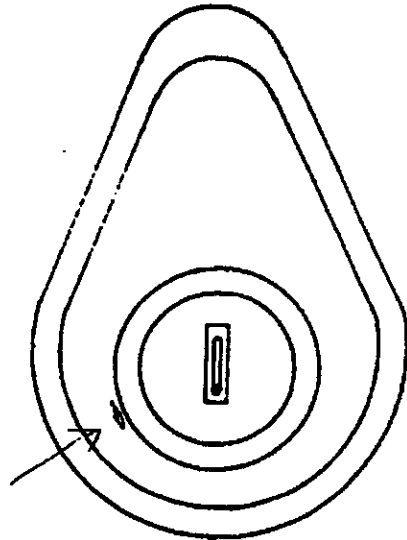
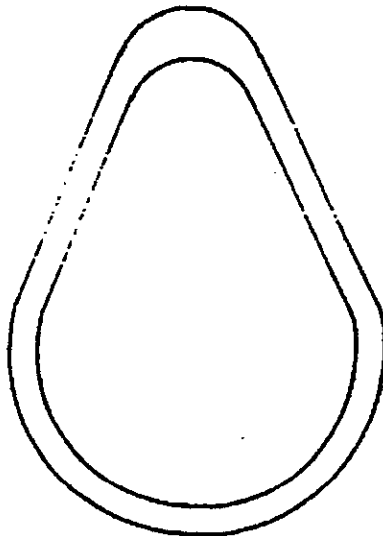
PICTORIAL REPRESENTATION
OF AFFECTED AREA(S)

Describe reported experience in detail (attach all pertinent correspondence, letters, invoices, packing lists, RGR's, etc.)
 Was a patient involved? Yes No
 Date of Surgery 8/1 Reason for Surgery replace alleged denture
 Will product be returned? Yes No RGA # _____ Expected MEC Return Date _____
 Is a response requested? Yes No To be directed to _____
 Detailed Information: Received 12/10/86 on RGR # 23483
Determined by Q.A. lab that unit had a
crease hole.

Complaint # _____
 Legal Dept. _____
Condition: 1. Crease hole, cause unknown
 Investigation MDR 50163R Product has been Used

1. Crease hole, cause unk.
2. _____
3. _____
4. _____

1. Trace card cannot be pulled as the lot number is unknown.
2. Manufacturing and inspection procedures are performed on all units to check for holes in the shells prior to packaging.
3. Q.A. Lab determined that the unit had a crease hole.
4. R & D also evaluated the unit, and the Q.A. Lab findings were confirmed.
5. The occurrence of crease holes in mammary implants is a state-of-the-art concern.
6. A statement in our package insert warns, "Implant may rupture and/or deflate due to material fatigue (i.e. crease fold phenomenon). If this phenomenon does occur, additional surgery may be required to remove..."
7. Additionally, we have decreased the recommended fill volume in our bilumen mammary implants to minimize the amount of fluid loss.
